PowerArchitect 5

5.2-r3

Release Notes

PowerArchitect 5 is an intuitive and powerful design tool used to program MaxLinear's Universal PMIC power controller and modules. This release has many usability and feature improvements as well as a number of bug fixes.

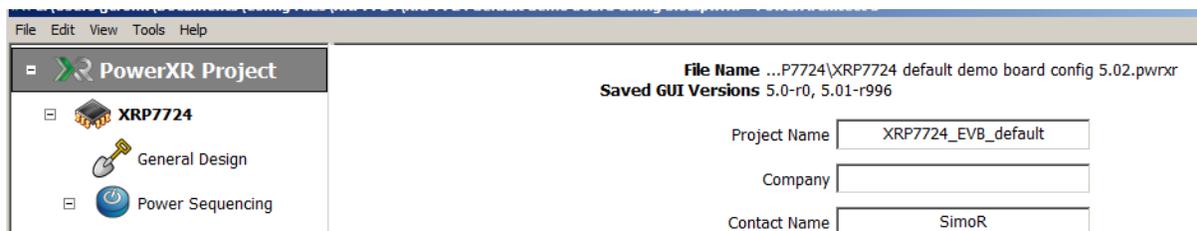
Figure 5: Saved GUI Versions

In the "PowerXR Project" tab, there is a new field called "Saved GUI Versions". The screen capture below shows an example of a project file saved in revision 5.0-r0 and then saved in the current version 5.02-r0.

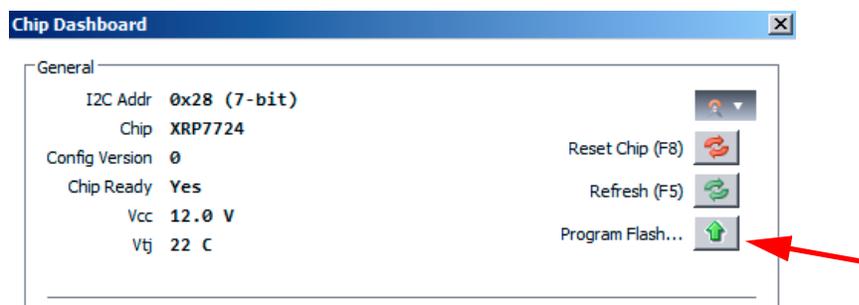
Figure 10: Program from Dashboard

Rather than requiring the user to go to the main menu, the chip may be re-programmed from the dashboard.
